Parker Lake Number 2 Dam (MO 30809).
Upper Mississippi - Mississippi - Kaskaskia -
St. Louis Basin. Perry County, Missouri,
Phase 1 Inspection Report.

PARKER LAKE #2 DAM
PERRY COUNTY, MISSOURI

MISSOURI INVENTORY NO. 30809

PHASE I INSPECTION REPORT
NATIONAL DAM SAFETY PROGRAM

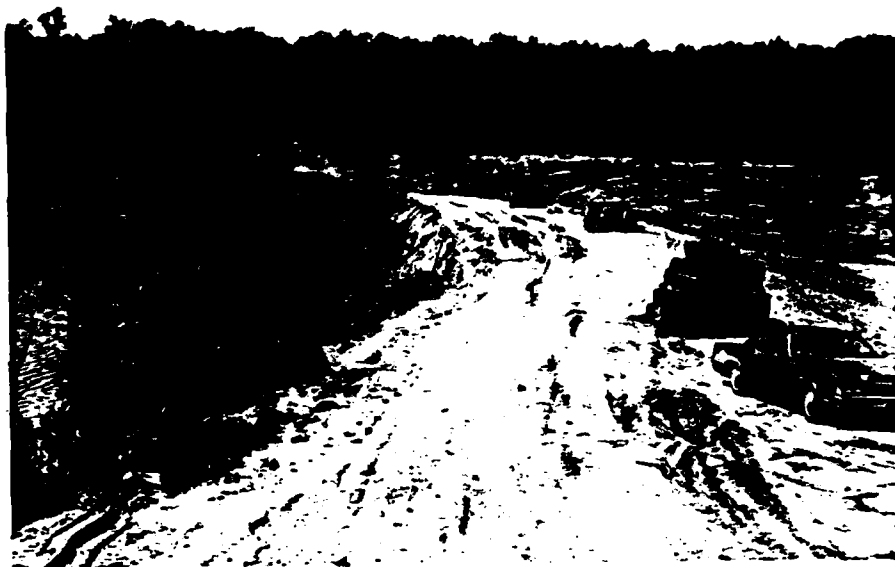
PHOTO 1 Overview of Lake and Dam

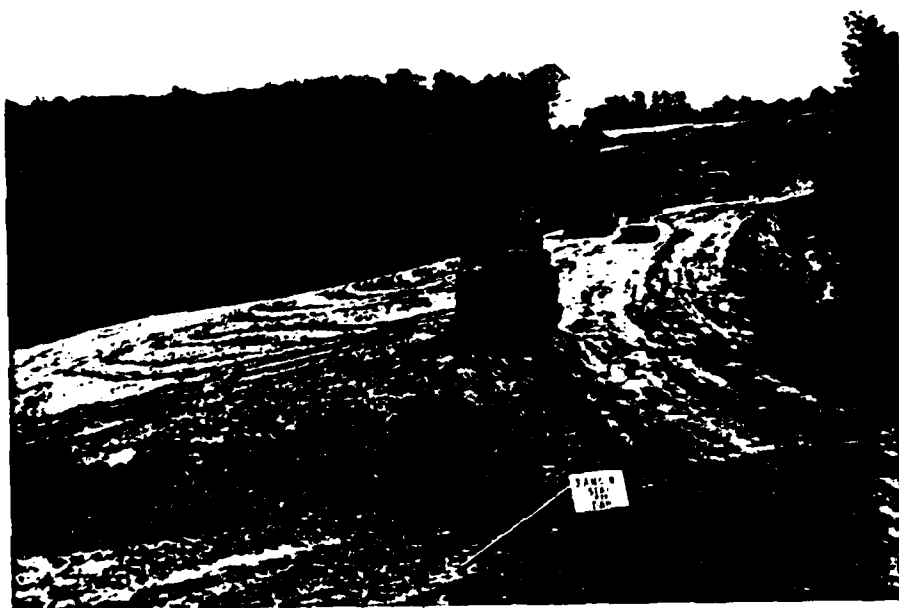
Several longitudinal cracks, 0.5-inch wide and 15 to 20 feet long, were observed on the crest right of the center of the dam and towards the right abutment. A large hump or bulge was found at the toe of the downstream face of the embankment and toward the left abutment. The crest of the bulge also showed signs of cracking. The cracks in the crest of the embankment and the bulge may be the result of the recent construction or may be evidence of some slope instability prior to the recent construction. It appears that the bulge was constructed to stop a leak that may have existed at that location (see Section 1.2g). Although the cracks in the crest and the bulge at the toe are at opposite ends of the dam, they may be related, however, this is only an assumption which should be further explored.

PHOTO 2 Crest of Dam

(3) The cause of the bulge mentioned in (1) above, and the cause of the cracks observed on the crest toward the right abutment should be determined to ascertain whether there is any relationship between the two, and if either or both pose a hazard to the stability of the dam.

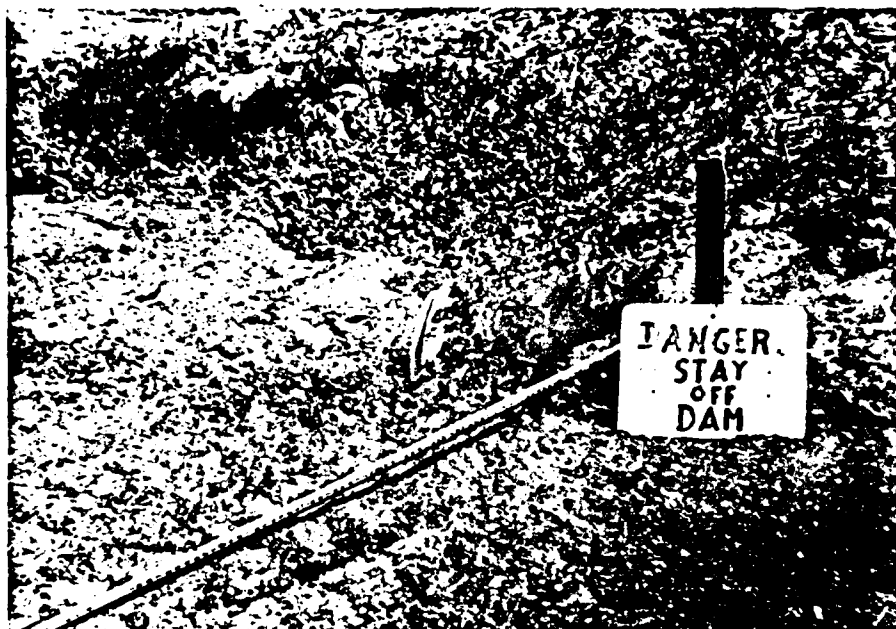
The right abutment or eastern spillway pipe is also partially blocked by debris and discharges onto the back slope of the embankment producing in our opinion, an undesirable outfall condition. Sustained discharges will endanger the integrity of the dam.

PHOTO 3 Eastern Spillway Exit and Sign.

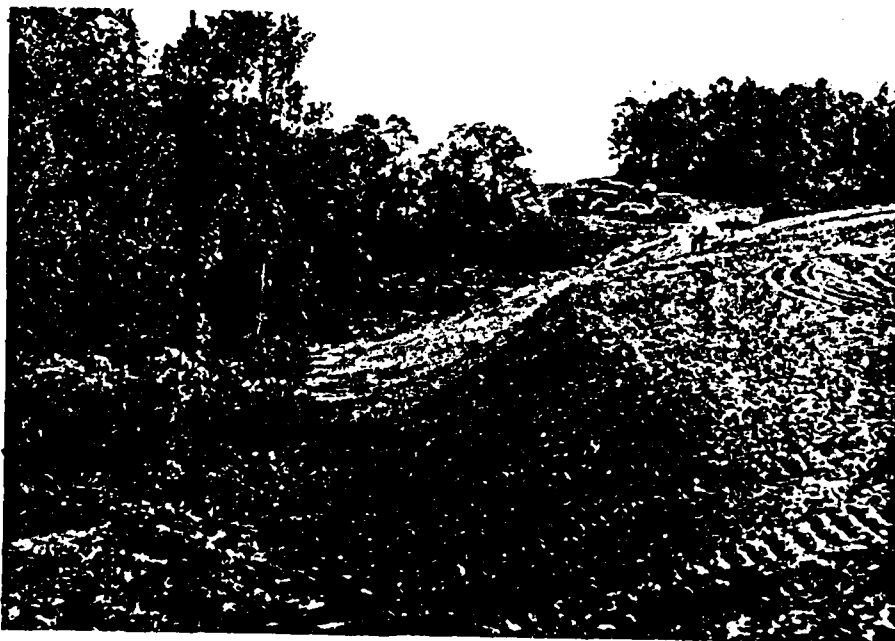
Standing water and seepage was observed at the toe of the bulge. Water was observed flowing at a rate of 20 to 40 GPM slightly to the right and downstream of the toe of the bulge. The water appeared iron-stained and oil-slicked. The ground below the bulge and the area toward the left abutment was soft and wet. No detrimental settlement, depressions, animal burrows, or present slope instability were observed, however, the recent construction may have covered or corrected existing deficiencies, if any.

2. Seepage evident at the base of the bulge is considered through-seepage which left uncontrolled may cause piping which would adversely affect the stability of the dam.

3. The bulge noted on the downstream slope of the dam is not a deficiency in itself, however, taken in conjunction with cracks noted on the crest of the dam may be evidence of a prior slope instability, which should be further explored.

PHOTO 8 Bulge in Downstream Slope of Embankment
Near Left Abutment

(1) Seepage observed at the toe and below a bulge on the downstream face of the embankment near the left abutment, should be monitored to determine the quantity of flow and sedimentation. Corrective measures should be designed based on appropriate analyses.
